BLACKFOOT AIRPORT (McCARLEY FIELD)

This report describes how your pavement maintenance management program was developed. This program was developed as part of the Network Pavement Management Program project sponsored by the Idaho Transportation Department, Division of Aeronautics. The information and data contained in this report ensures you are in compliance with the requirements of Federal Aviation Administration (FAA) Grant Assurance Number 11 which states that any airport requesting federal funds for pavement improvement projects must have implemented a pavement maintenance management program (PMMP).

Using the branch, section and sample unit divisions established, a visual condition survey was conducted at Blackfoot Airport (McCarley Field) on November 03, 2006. During the inspection pavement defects were identified and measured in accordance with the methodology outlined in FAA AC:150/5380-6 and ASTM D5430. Our inspection ensures your airport complies with the “detailed inspection” requirement of FAA’s PMMP guidelines. After collection, the data were entered into the Micro PAVER software for analysis. These data are reproduced in the Re-Inspection Report attached in Appendix

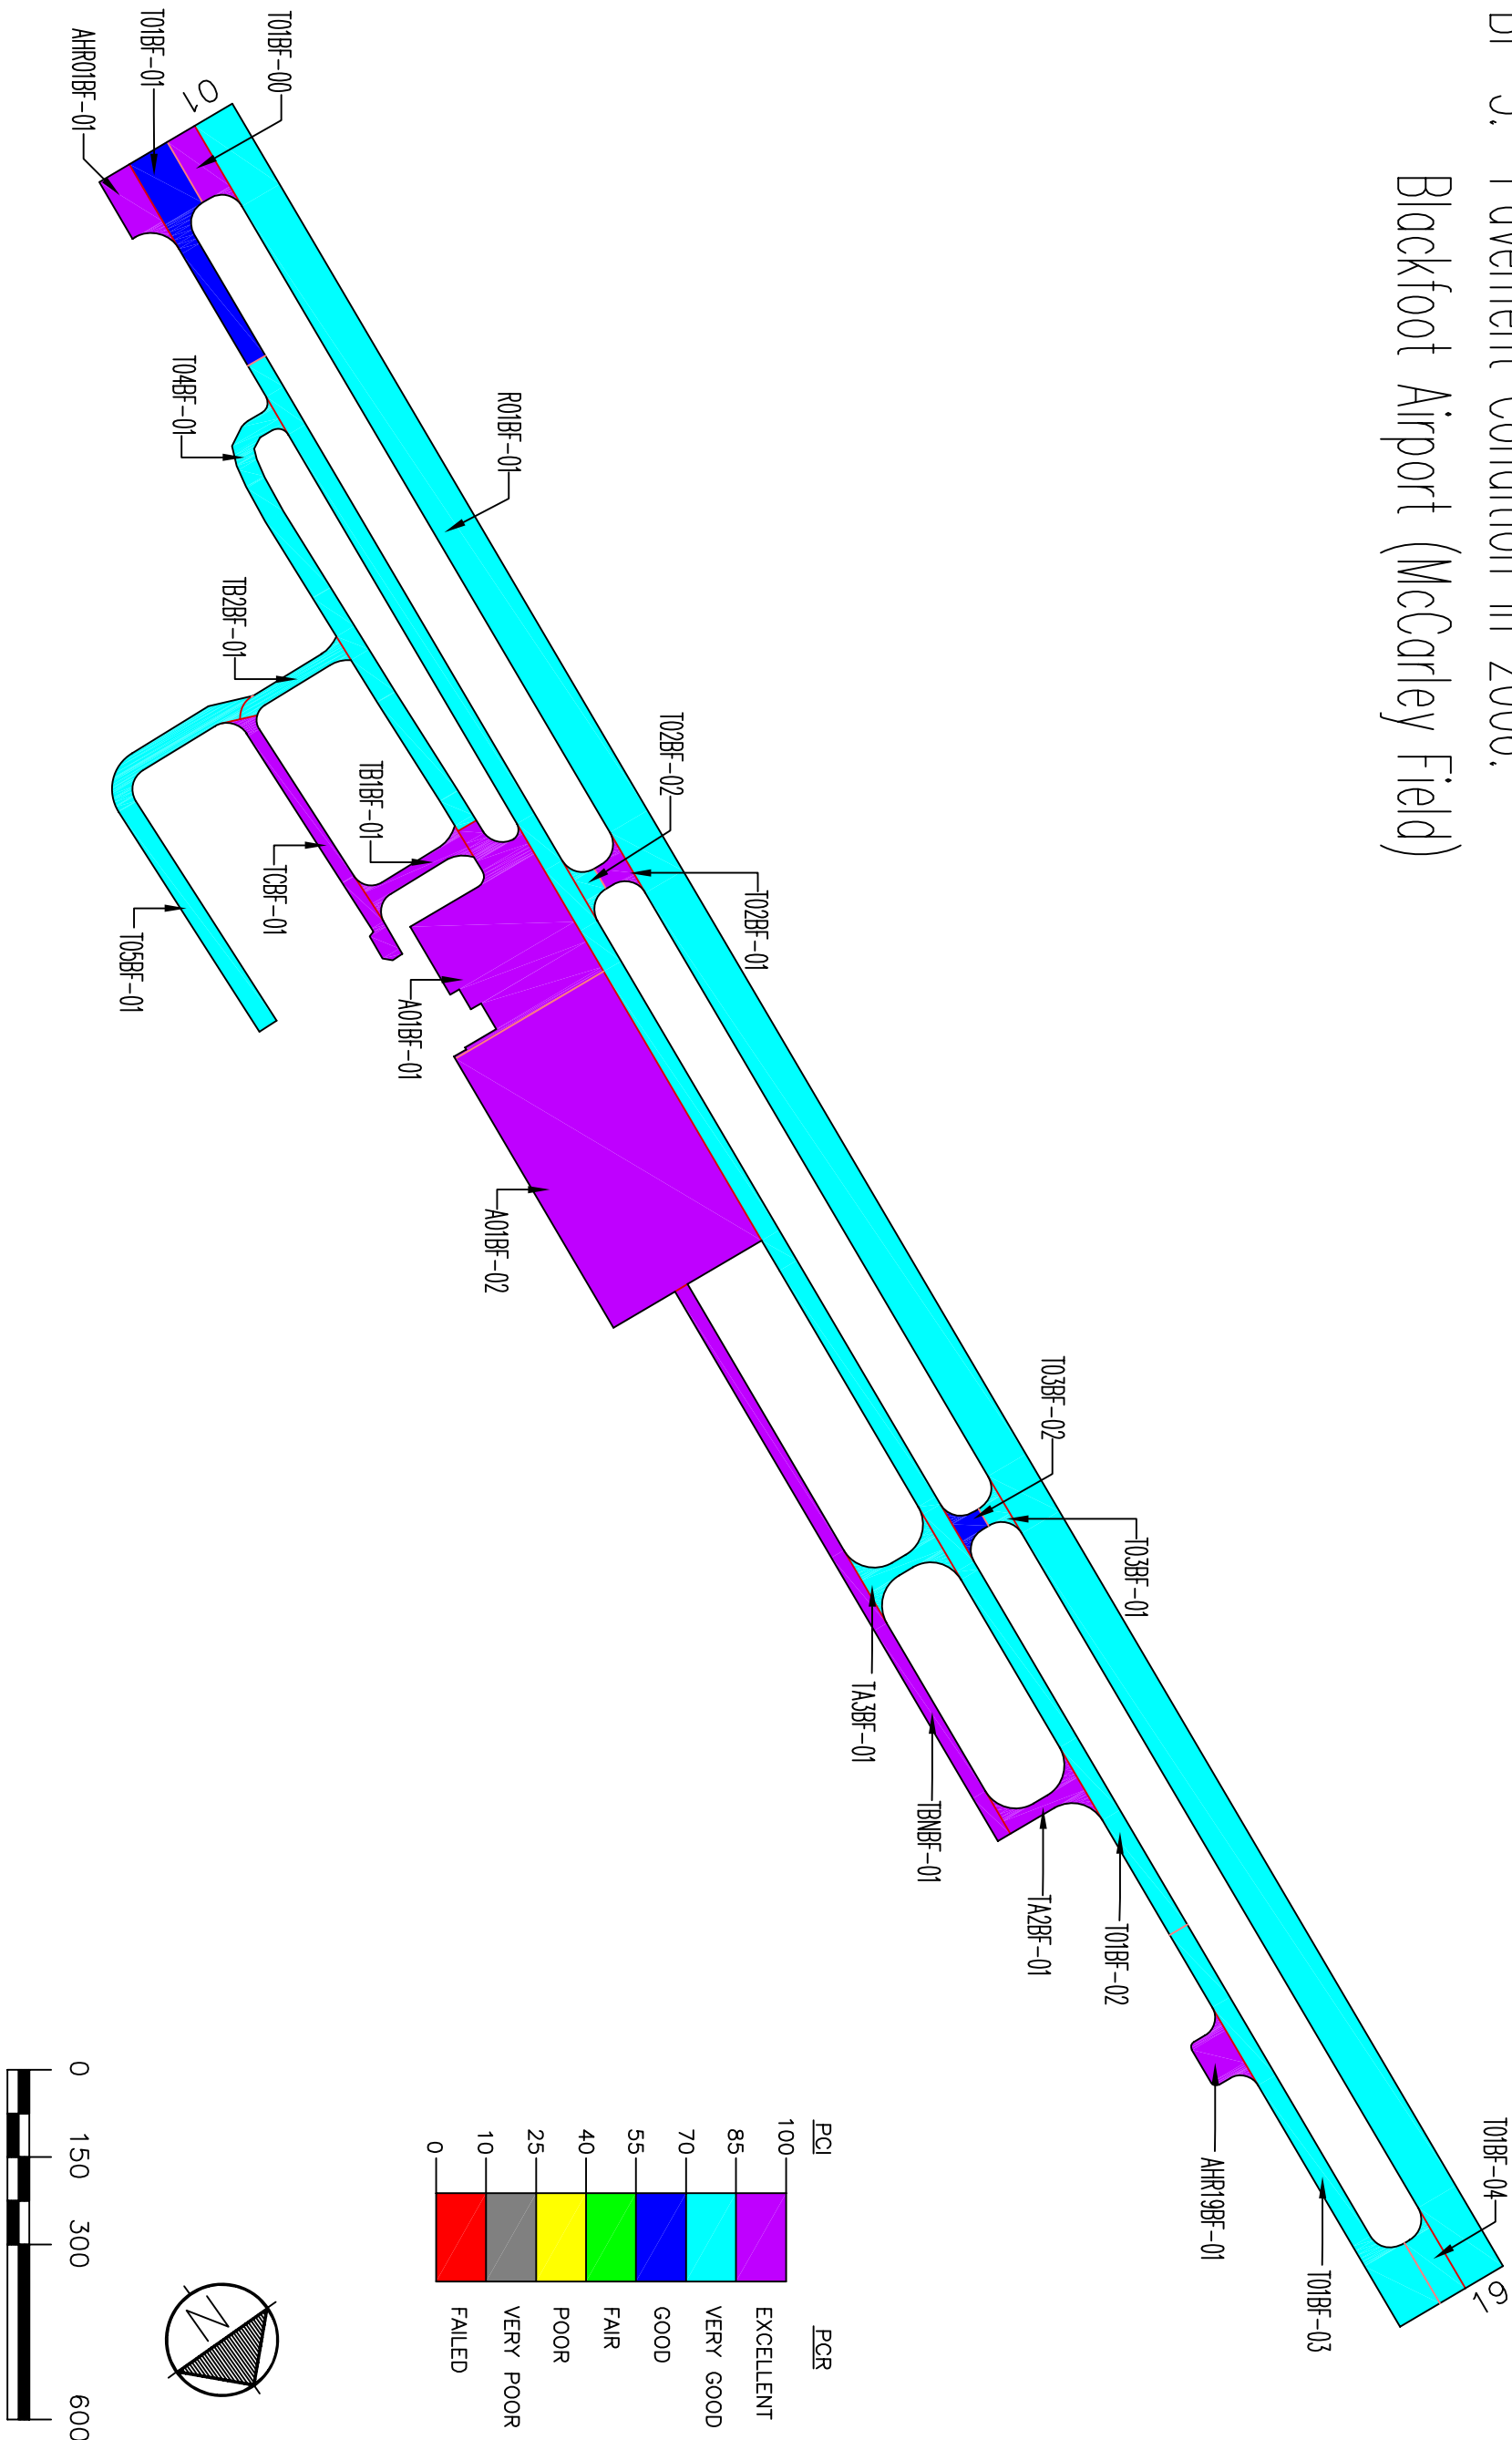
Figure BF-3. Pavement Condition in 2006.
Blackfoot Airport (McCarley Field)

Section PCIs at the airport range from a low of 64 (a PCR of “Good”) to a high of 100 (a PCR of “Excellent”). The area-weighted average PCI for all airport pavements is 85, corresponding to an overall PCR of “Very Good”. Figure BF-4 shows how much pavement area is associated with each Pavement Condition Rating category and also shows pavement condition distribution from the inspections conducted in 1996 and 1999. A graphical representation of the projected PCRs presented in Table BF-2 is shown in Figure BF-5.

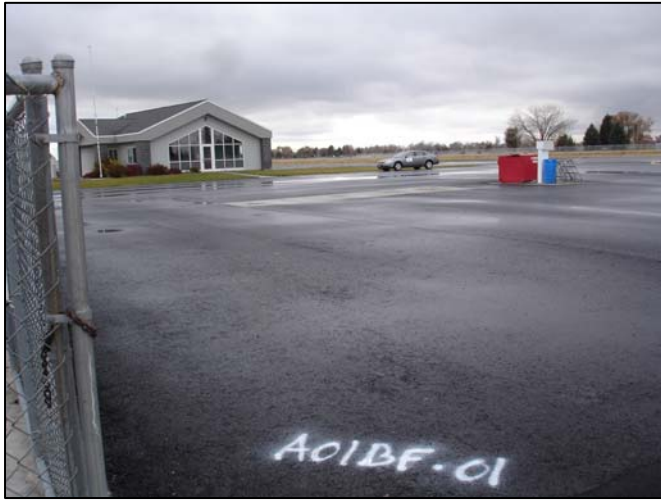
Sample Number: 01 Type: R Area: 4,700.00SqFt PCI = 68
45 DEPRESSION L 699.99 SqFt

Sample Number: 06	Type: R	Area: 5,000.00SqFt	PCI = 90
45 DEPRESSION		L 80.00 SqFt

Sample Number: 10	Type: R	Area: 5,000.00SqFt	PCI = 81
45 DEPRESSION		L 240.00 SqFt

Section: A01BF-01
Depression

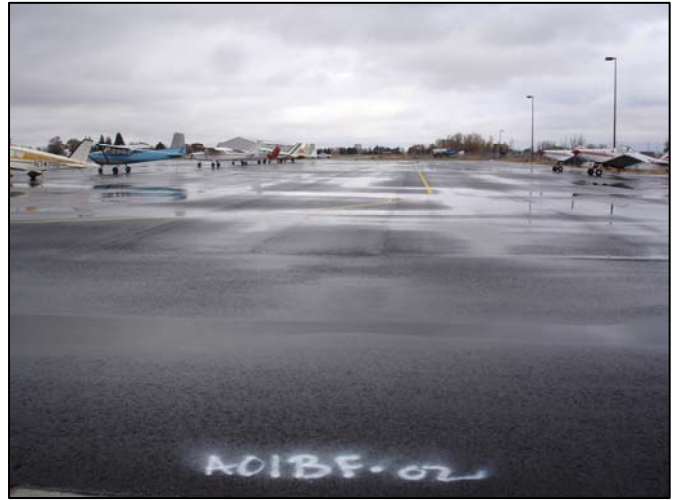
Sample Number: 02	Type: R	Area: 4,500.00SqFt	PCI = 80
45 DEPRESSION		L 250.00 SqFt	
Sample Number: 08	Type: R	Area: 5,000.00SqFt	PCI = 100
<NO DISTRESSES>			
Sample Number: 14	Type: R	Area: 5,000.00SqFt	PCI = 100
<NO DISTRESSES>			
Sample Number: 21	Type: R	Area: 5,000.00SqFt	PCI = 100
<NO DISTRESSES>			
Sample Number: 27	Type: R	Area: 5,000.00SqFt	PCI = 100
<NO DISTRESSES>			
Sample Number: 32	Type: R	Area: 5,000.00SqFt	PCI = 100
<NO DISTRESSES>

Section: A01BF-02
Depression

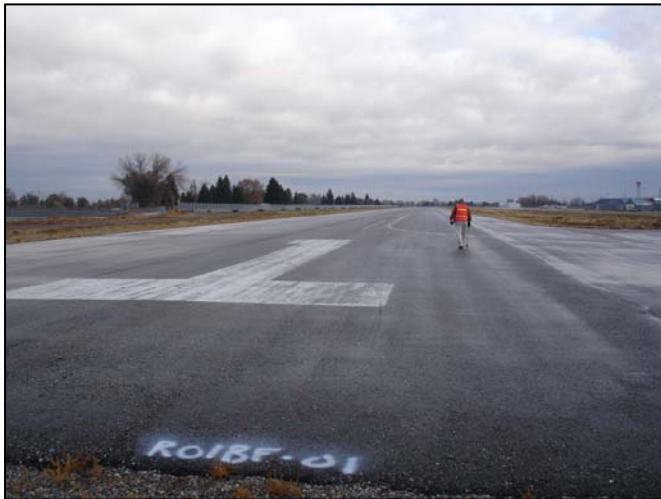
Last Insp. Date: 11/3/2006 Total Samples: 57 Surveyed: 6
Conditions: PCI: 83.00 |

Sample Number: 01 Type: R Area: 5,625.00SqFt PCI = 82
48 LONGITUDINAL/TRANSVERSE CRACKING L 100.03 Ft
48 LONGITUDINAL/TRANSVERSE CRACKING M 79.02 Ft

Section: R01BF-01
Longitudinal/ Transverse Cracking

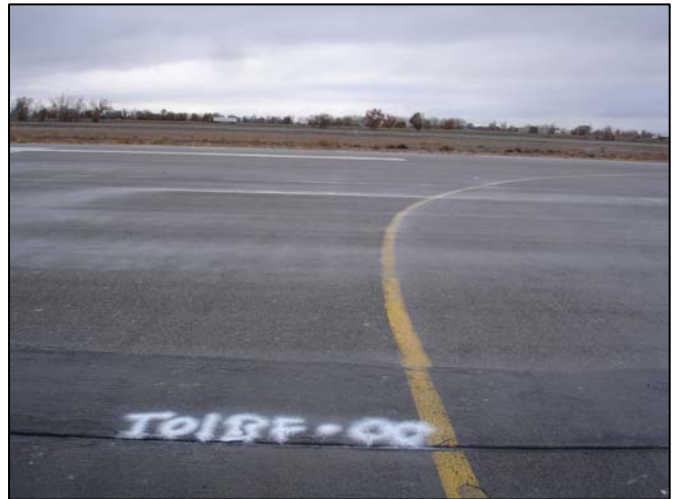
Sample Number: 01 Type: R Area: 6,913.00SqFt PCI = 89
48 LONGITUDINAL/TRANSVERSE CRACKING L 238.06 Ft

Section: T01BF-00
Longitudinal/ Transverse Cracking

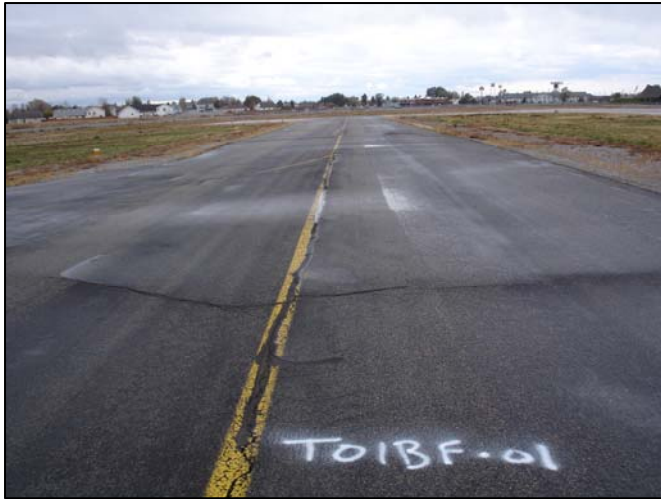
Section: T01BF-01
Longitudinal/ Transverse Cracking

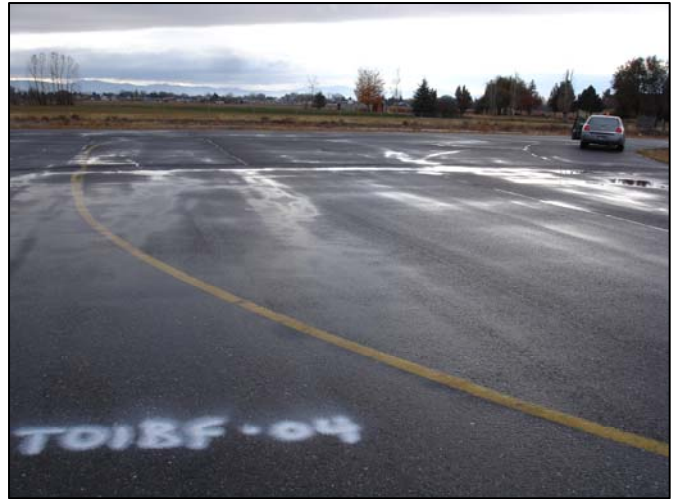
Section: T01BF-04
Longitudinal/ Transverse Cracking

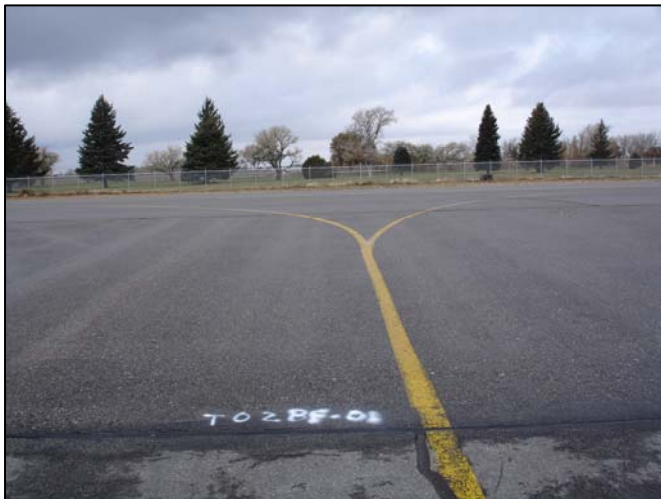
Section: T02BF-01
Longitudinal/ Transverse Cracking

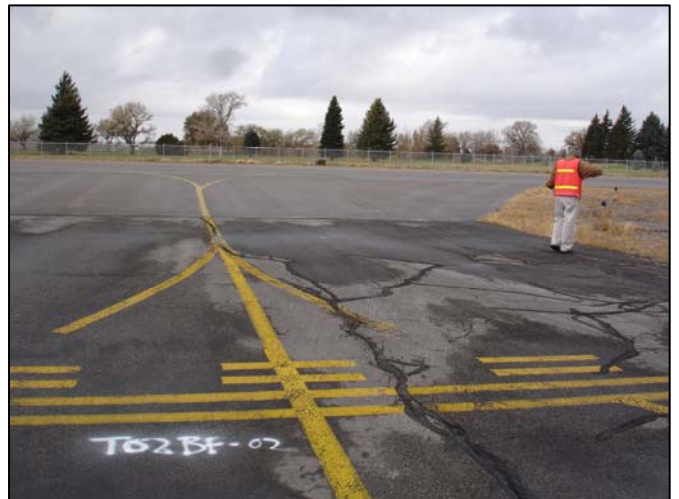
Section: T02BF-02
Block Cracking

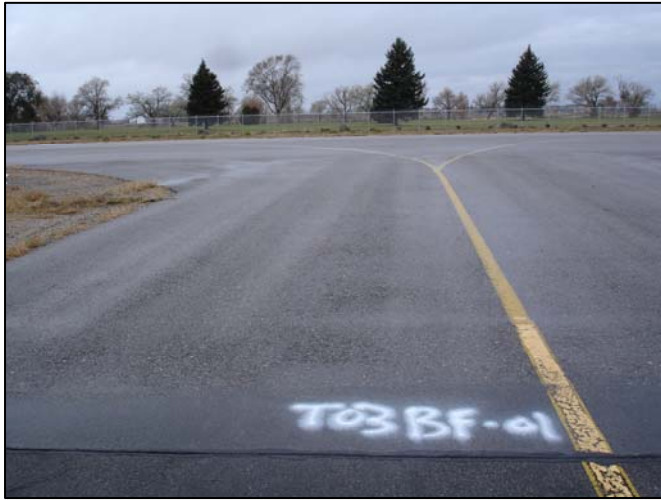
Section: T03BF-01
Longitudinal/ Transverse Cracking

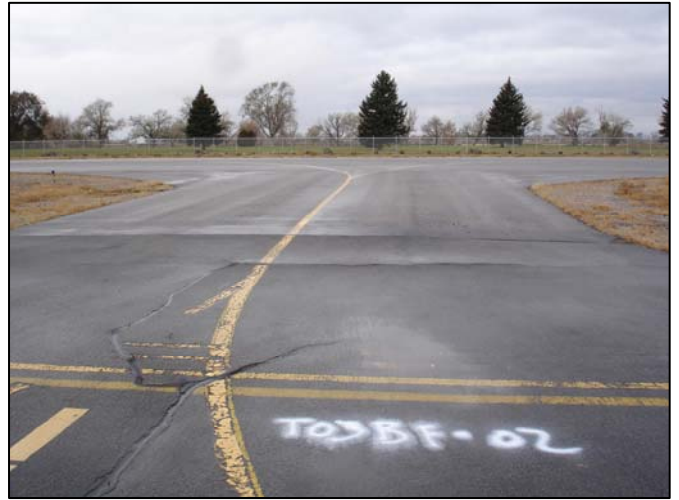
Section: T03BF-02
Longitudinal/ Transverse Cracking

NOTE: T03BF-02 needs to be overlayed in 2011.

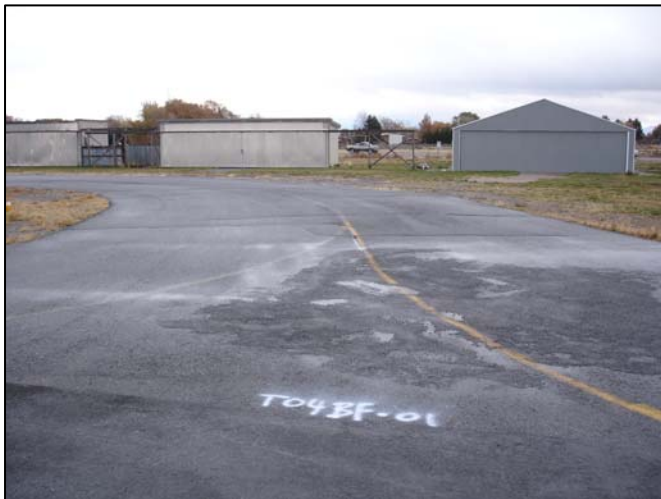
Section: T04BF-01
Longitudinal/ Transverse Cracking

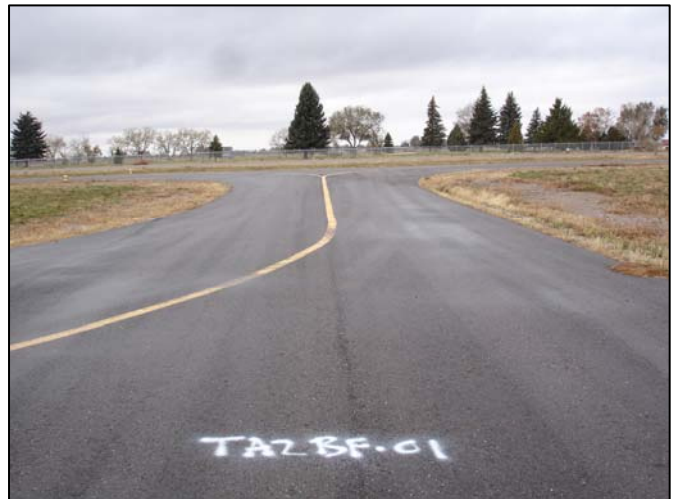
Section: TA2BF-01
Longitudinal/ Transverse Cracking

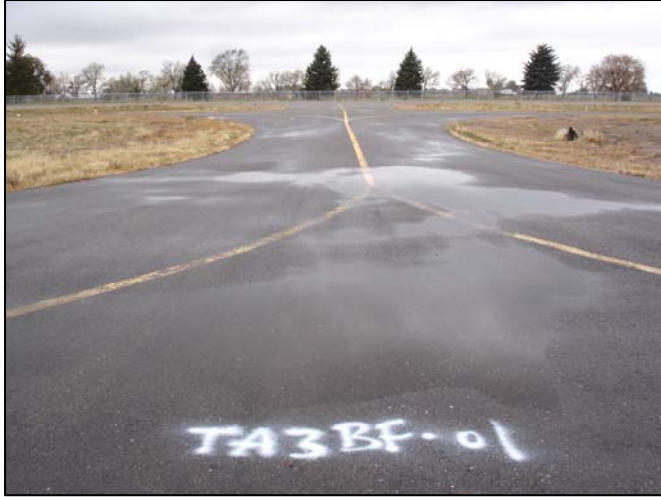
Sample Number:	01	Type:	R	Area:	6,778.00SqFt	PCI = 77
45	DEPRESSION			L	190.00 SqFt	
48	LONGITUDINAL/TRANSVERSE CRACKING			L	135.03 Ft	
48	LONGITUDINAL/TRANSVERSE CRACKING			M	4.00 Ft

Section: TA3BF-01
Longitudinal/ Transverse Cracking, and
Depression

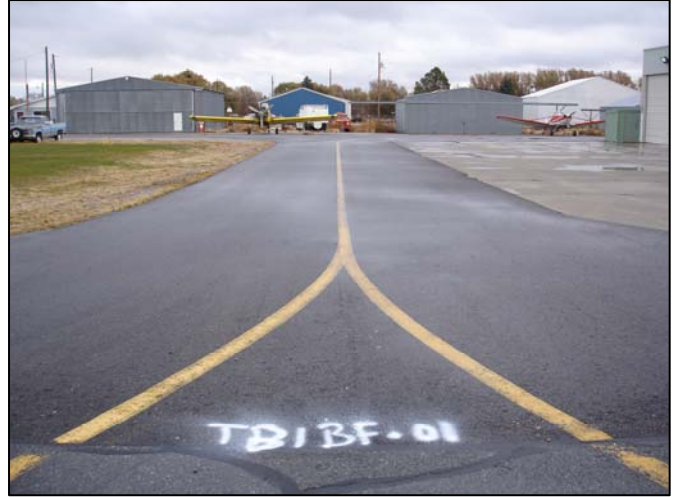
Sample Number: 01 Type: R Area: 5,833.00SqFt PCI = 94
48 LONGITUDINAL/TRANSVERSE CRACKING L 92.02 Ft

Section: TB1BF-01
Longitudinal/ Transverse Cracking

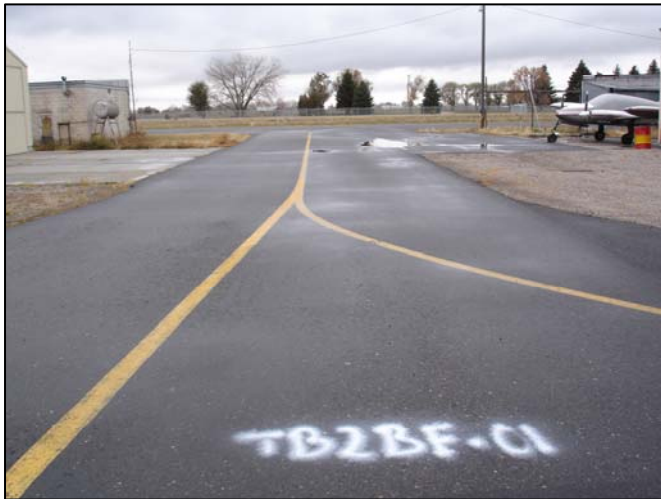
Section: TB2BF-01
Depression

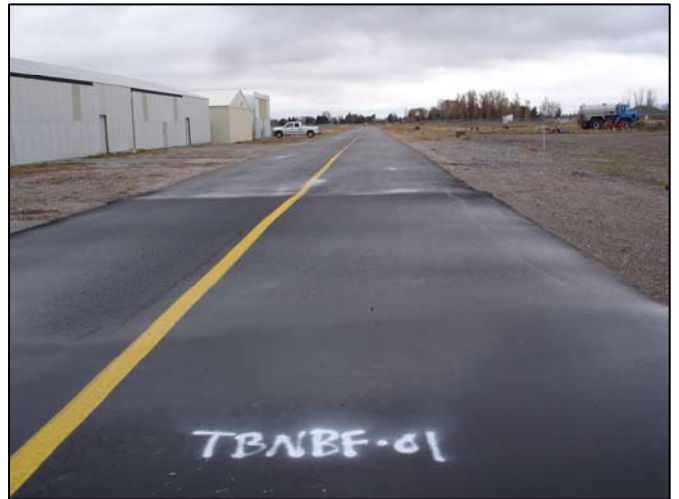
Section: TBNBF-01
No Distress
